DEPARTMENT OF TRANSPORTATION**DIVISION OF ENGINEERING SERVICES**

Contract #: 04-0120F4Cty: SF/ALA Rte: 80 PM: 13.2/13.9File #: 99.28**WELDING INSPECTION REPORT****Resident Engineer:** Pursell, Gary**Address:** 333 Burma Road**City:** Oakland, CA 94607**Report No:** WIR-002934**Date Inspected:** 02-Jun-2008**Project Name:** SAS Superstructure**OSM Arrival Time:** 2230**Prime Contractor:** American Bridge/Fluor Enterprises, a JV**OSM Departure Time:** 830**Contractor:** Japan Steel Works, Ltd.**Location:** Muroran, Japan

CWI Present:	Yes	No	
Rod Oven in Use:	Yes	No	N/A
Weld Procedures Followed:	Yes	No	N/A
Verified Joint Fit-up:	Yes	No	N/A
Approved WPS:	Yes	No	N/A
Delayed / Cancelled:	Yes	No	N/A
Component:	Tower, Jacking and Deviation Saddles

On this date OSM Quality Assurance (QA) Representative Daniel L. Reyes was present during the repair welding of the Saddle Casting. The following was observed:

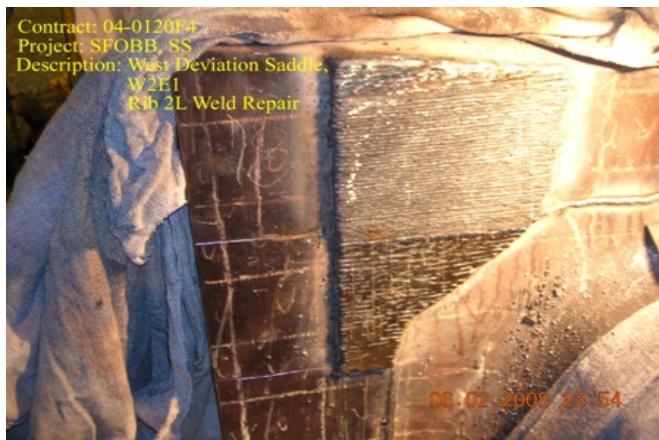
The QA inspector observed the welding performed by Japan Steel Welding, Ltd. (JSW) welding personnel Kazuya-Komai on the rib 2L with the repair area identified as 3-8. The welder, Kazuya-Komai performed the repair welding in the horizontal (2G) position with the work in the vertical plane and the axis of the weld horizontal and utilized the Shielded Metal Arc Welding (SMAW) process as per the Welding Procedure Specification (WPS) identified as SJ-3026-2. The consumable utilized by the JSW welder appeared to be a Hobart Brothers Product identified as LB-106, with the diameter size of 5.0 mm which appeared to comply with the AWS Specification A5.5 and the AWS Classification E10016-G.

This QA inspector randomly observed the in process Shielded Metal Arc Welding (SMAW) for the repair welding of the rib on the West Deviation Saddles identified as W2E1. This QA inspector noted that it appeared the approved and latest revised WPS's were posted at the appropriate welding station and that each approved welder was entered in the latest revised Welding Personnel Log issued by Japan Steel Works, Ltd. The welding parameters, preheat and interpass temperatures were verified as noted by this QA inspector utilizing a Fluke 337 clamp meter for the electrical welding parameters and Tempilstik temperature indicators for preheat and interpass temperatures. The filler metal utilized at the welding stations was also verified. The welding and inspection was not completed during this shift and appeared to be in general compliance with the contract documents.

The following digital photograph illustrate the observations of the activities performed on this date.
